**NATIONAL SCIENCE FOUNDATION**

OFFICE OF  
INSPECTOR GENERAL

RE: Closeout – Investigation

## Shooting Report

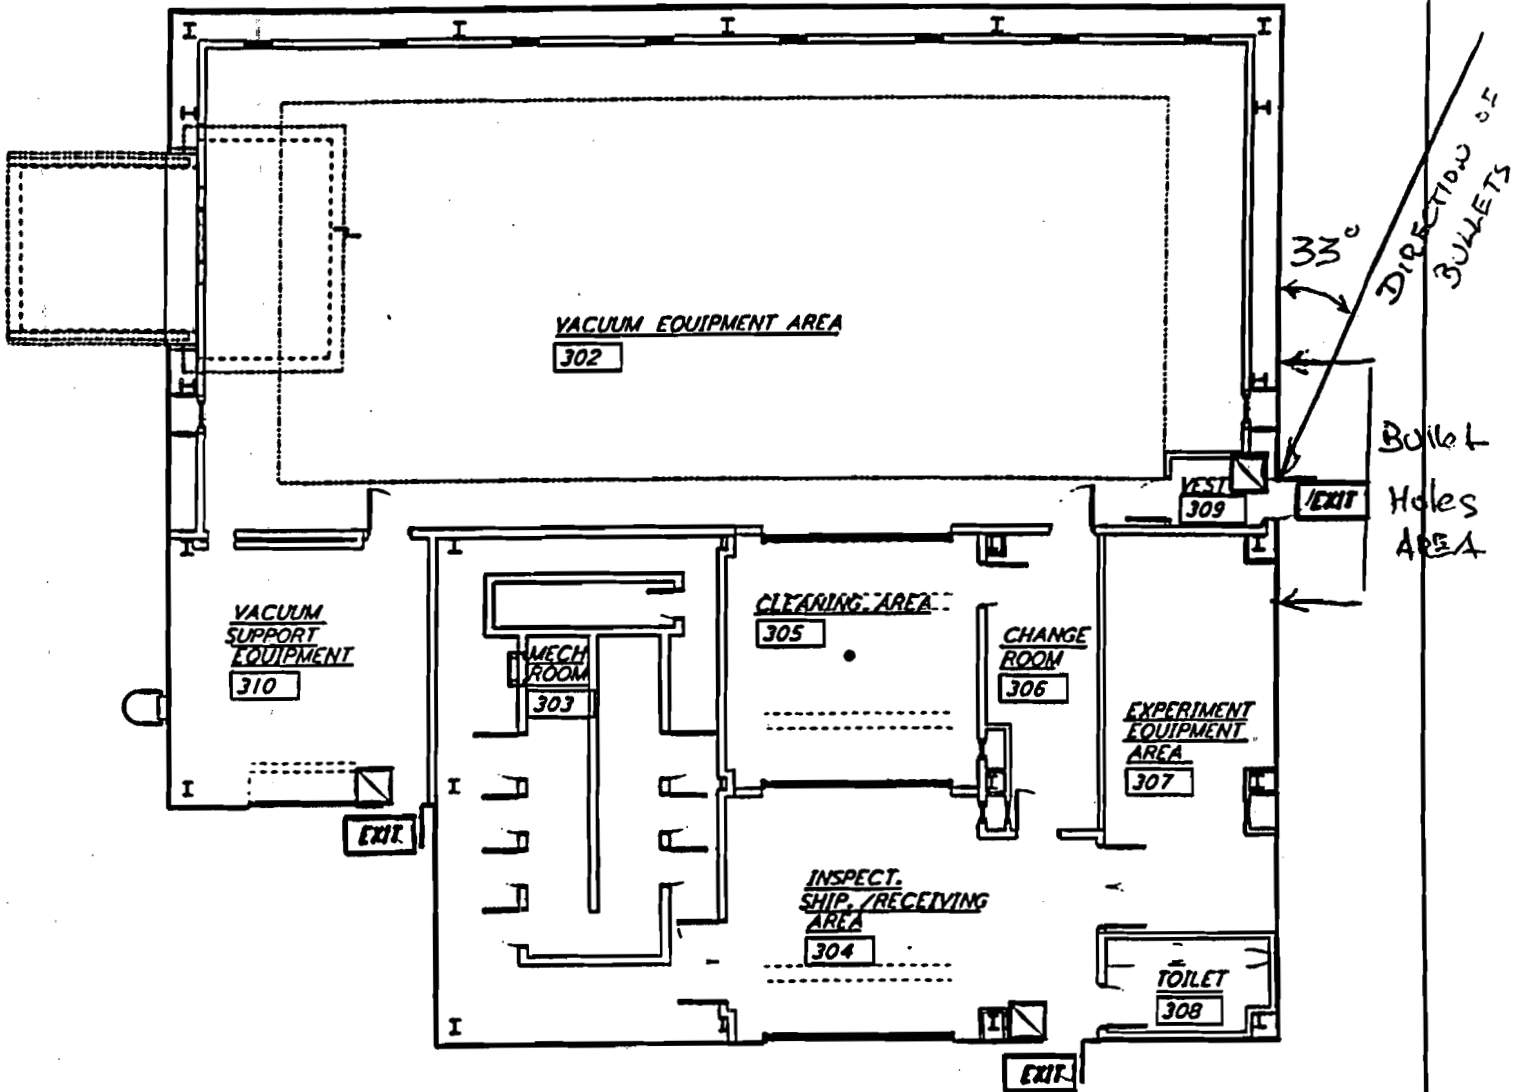
# ATTACHMENT A

The evidence at the west-end building revealed that the nine shots were fired at a downward trajectory to the building. A tenth shot was fired at an undetermined angle and struck the upper southwest corner of the building. Both Sheriff's Office Detectives and NSF-OIG investigators concurred that the shots were fired from the property to the southwest of the west-end building property, due to the higher elevation of that property. Trees and foliage and the sloping terrain surrounding the facility would have prevented the shots from coming from another location. The Sheriff's Office sent a slug recovered from the interior of the west-end building for analysis. The slug was identified as coming from a .380 or a .357 caliber weapon. Due to the pattern of the bullet holes around the light fixture on the west-end building, investigators concluded that the shooter was targeting the light. (Photographs 1 through 5) See Attachment A for a schematic of the west-end building.
